**Travel Motors Direct Ltd**

MetalTest Job No. J17033

**Subject:** A gear and associated annulus from a 2 stage reduction gearbox installed in a 6 tonne digger was submitted for chemical analysis and metallurgical examination to assess their respective qualities.

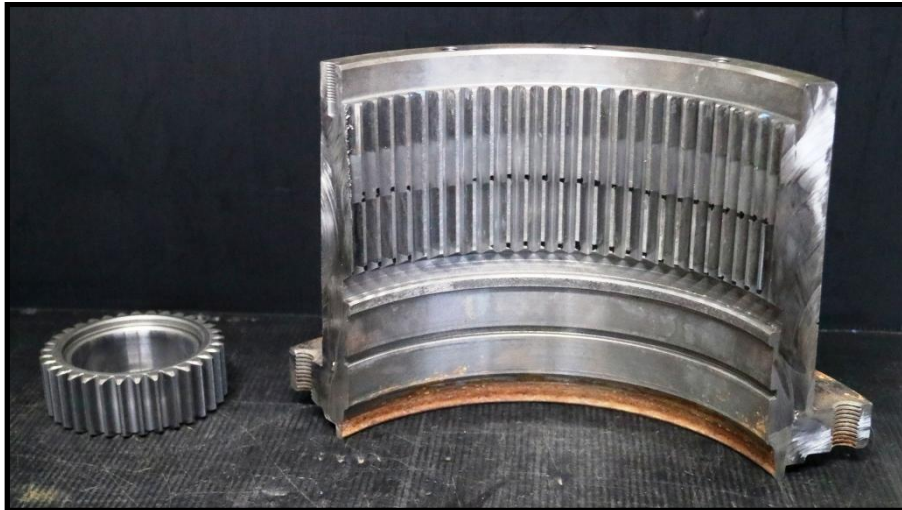
**Photograph A**

Sample of gear and annulus as received

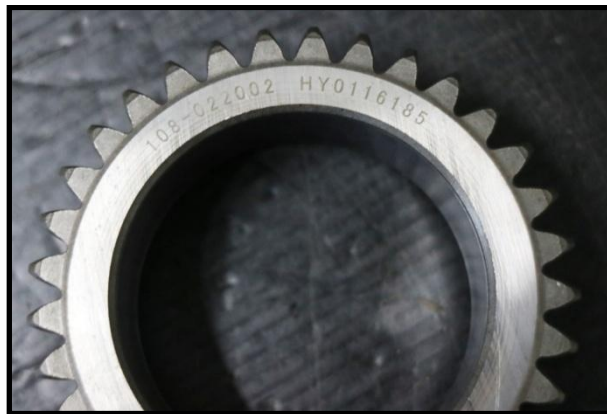
**Photograph B**

Gear identification

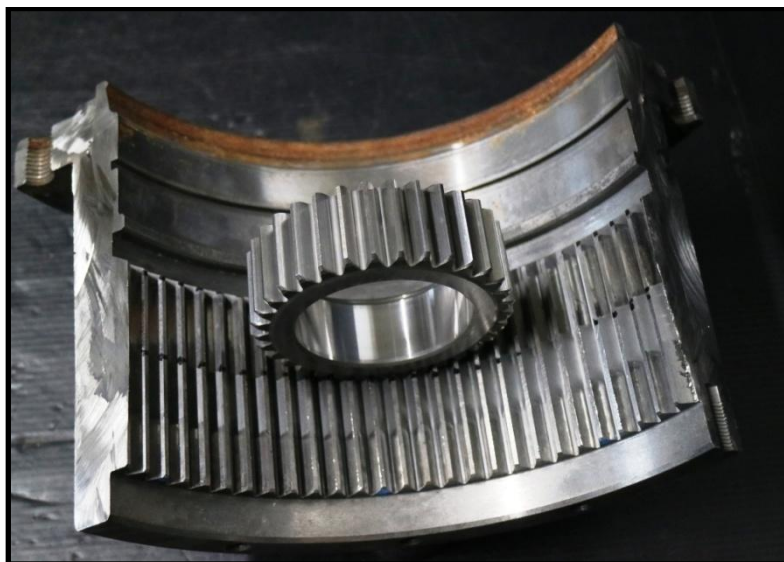
**Photograph C**

- The combination of an as-cast ductile iron annulus with shrinkage porosity in contact with a carburized gear is an **unbelievably** poor combination of materials for a heavy duty gearbox.

Gear in contact position within the annulus

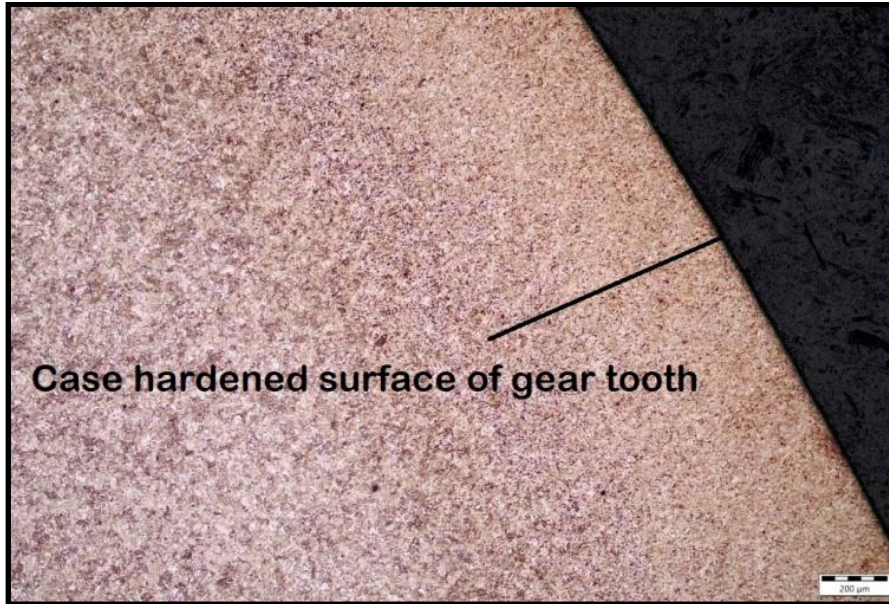
### Microphotograph A

- The gear has been manufactured from steel conforming to AISI 5120 grade steel or equivalent. This is a common medium duty carburizing steel.
- Effective case depth was determined to be 0.95mm at 550HV.
- Surface hardness of the gear teeth was determined to be 710HV in a tempered martensite matrix with a bainite core of hardness 430HV.
- We are advised that this is a heavy duty gearbox and hence we would have expected the gear to have been manufactured from nickel-chromium-molybdenum steel such as EN39B or E110 for improved toughness.

Case hardened surface of gear teeth @50x magnification - etched

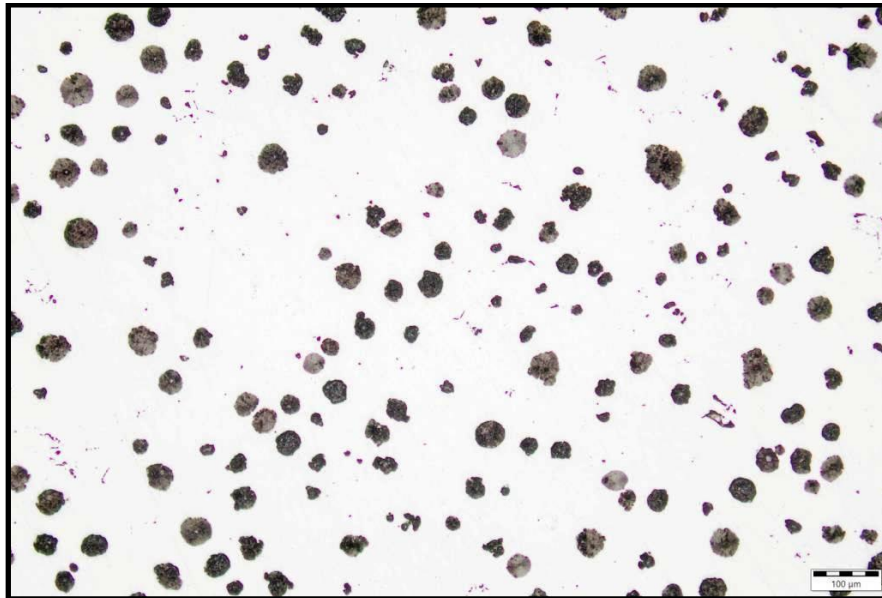
### Microphotograph B

- The annulus has been manufactured from ductile (SG) cast iron.
- The annulus is in the as-cast condition and has not been annealed or normalized as evident by the presence of “bullseye” ferrite surrounding the graphite nodules
- Metallurgical examination finds graphite morphology to have 95% nodularity with a 50/50 ferrite pearlite matrix with graphite size 5.
- Hardness was determined to be 215HV.
- Hence we have a relatively soft annulus gear – 215HV - running against a gear with a surface hardness of 710HV which will likely result in premature wear of the annulus.
- However what was incredulous to find was casting shrinkage porosity at the root of the annulus gear teeth which results in little or no impact resistance for the annulus.

Graphite morphology of annulus @100x magnification – as polished

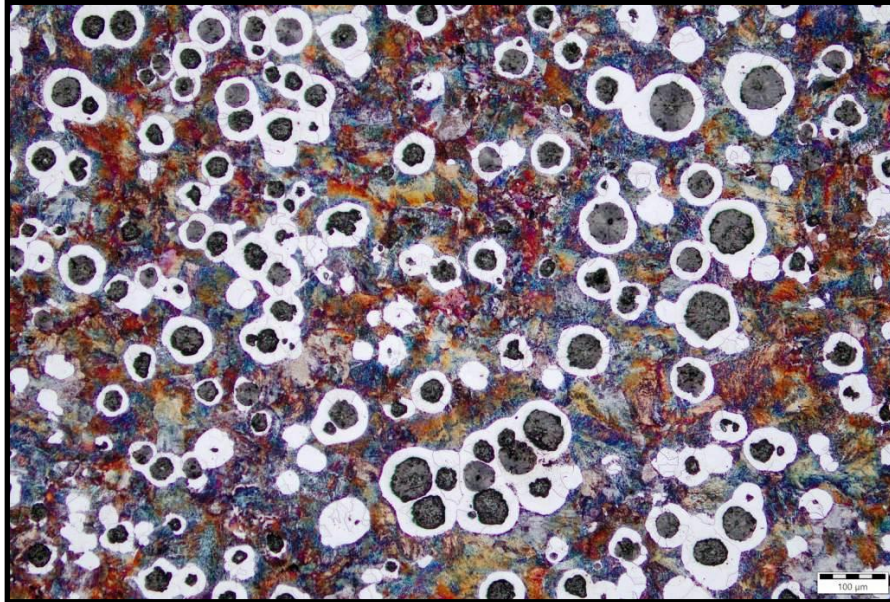
### Microphotograph C

- Additionally the annulus is in the as-cast condition and has not been annealed or normalized. SG iron castings such as this annulus given the service conditions in which it operates should never be used in the as-cast condition.

Graphite morphology of annulus @100x magnification – etched – revealing the presence of “bullseye” ferrite indicating the annulus is in the as-cast condition

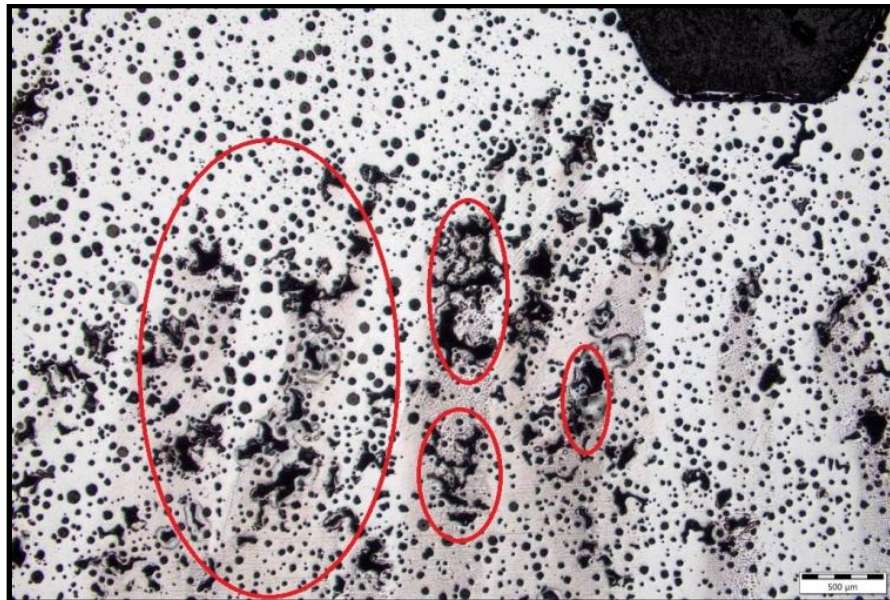
### Microphotograph D

Metallurgical examination finds the annulus is in the as-cast condition where we observe shrinkage porosity at the root of the gear teeth. Hardness was determined to be 215HV.

Shrinkage porosity in root of annulus gear teeth

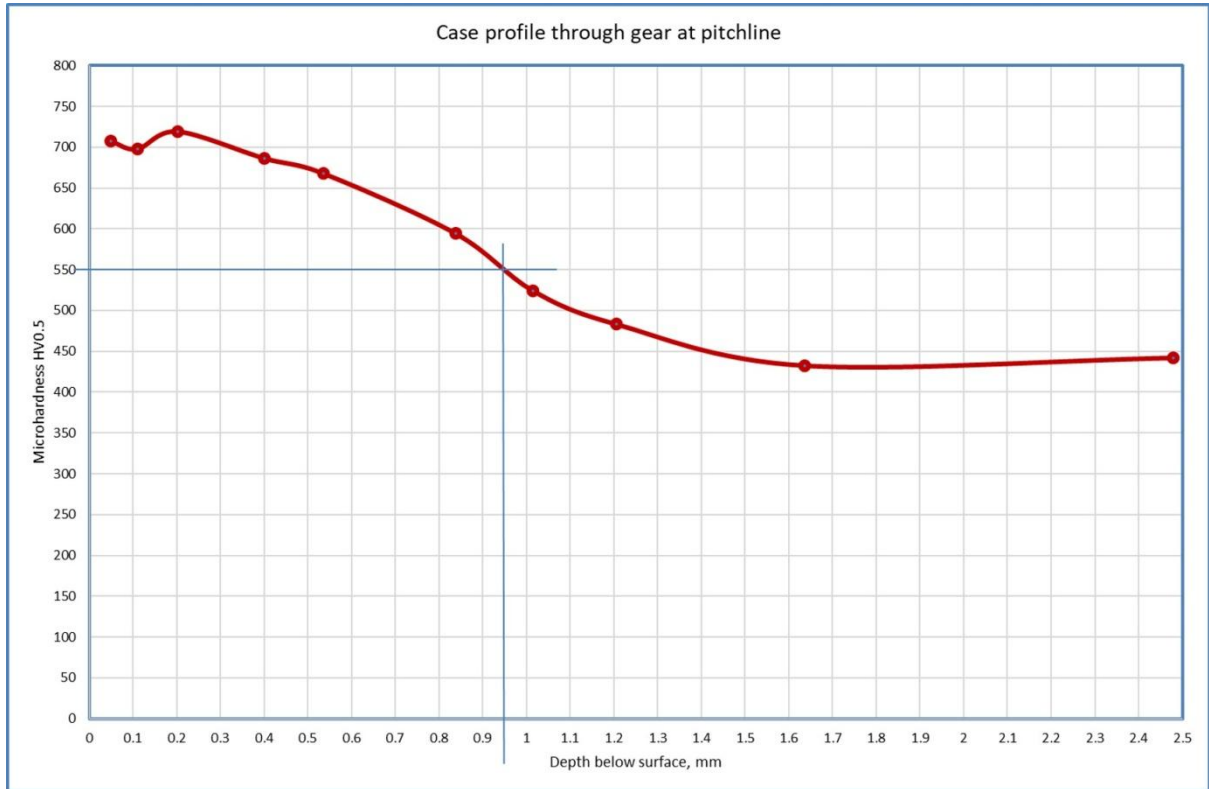
## Appendix A

See **Appendix A** for determination of effective case depth which was measured to be 0.95mm to 550HV.

Effective Gear Case Depth
